December 1944 as
Memorandum Report A4L18

HIGH-SPEED WIND-TUNNEL TESTS OF SEMISPAN HORIZONTAL
TAILS WITH FABRIC-COVERED AND METAL-COVERED
ELEVATORS FOR A BOMBER AIRPLANE

MEMORANDUM REPORT

Air Technical Service Command, U.S. Army Air Forces
HIGH-SPEED WIND-TUNNEL TESTS OF SEMISPAN HORIZONTAL
TAILS WITH FABRIC-COVERED AND METAL-COVERED
ELEVATORS FOR A BOMBER AIRPLANE

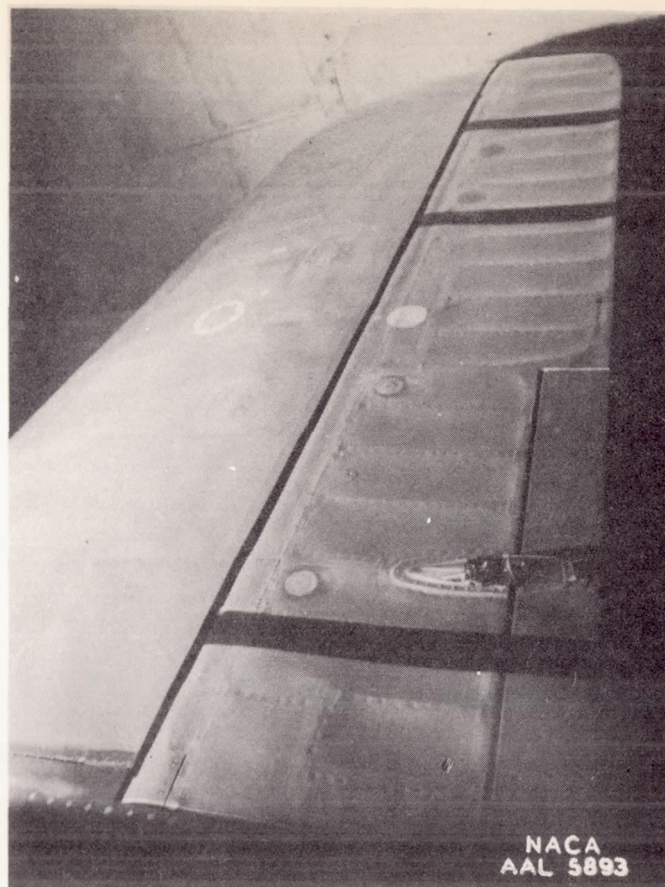
(a) Upper surface.

(b) Lower surface.

Figure 14.- The bomber stabilizer with the fabric-covered elevator. M , 0.72; α_t , -3° ; δ_e , 0° .

The deformations of the fabric-covered and metal-covered elevators at 0.72 Mach number are shown in figures 14 and 15. These figures show that the fabric was distorted to a concave shape on both the upper and lower surfaces, as was true under all conditions tested. In figure 15 it is seen that the metal surface was slightly distorted so that its characteristics are not those of a rigid surface. From these pictures it should be recognized that the differences shown in comparing the fabric surface with the metal surface are not as large as the differences between the fabric-covered elevator and a rigid-surface elevator.

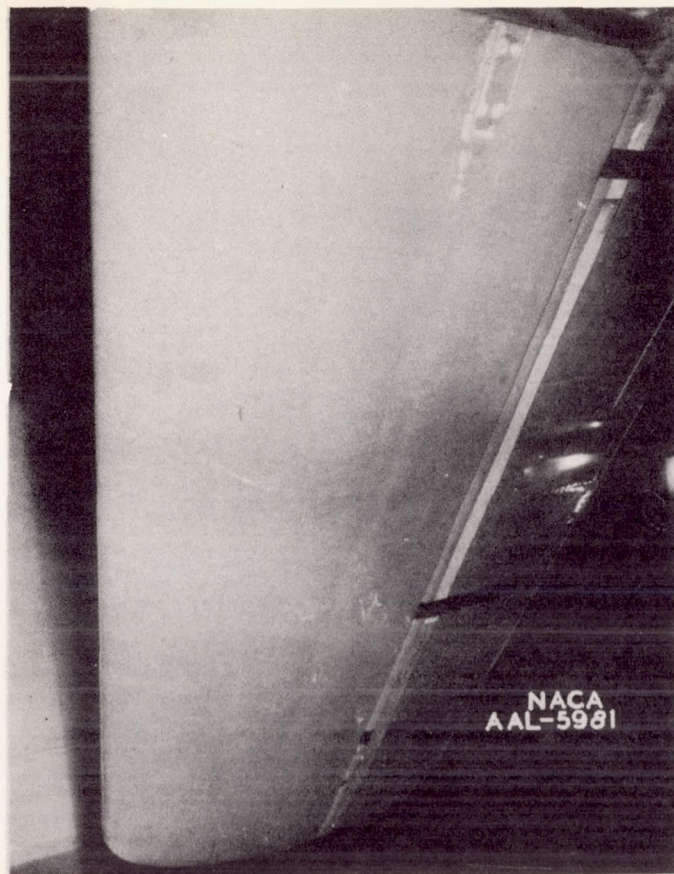
(a) Upper surface.

(b) Lower surface

Figure 15.- The bomber stabilizer with the metal-covered elevator. $M, 0.72$; $\alpha_t, -3^\circ$; $\delta_e, 0^\circ$.

The metal covering also distorted slightly (fig. 15(b)); therefore, when designing this type of surface the distortion must be considered.
